# Building Inspection

## Sample Report

Inspection Reference: Sample Building 2011  
Inspection Date: Inspection Date

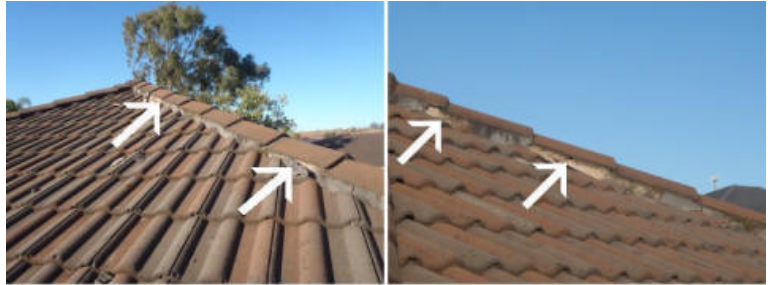
The mortar bed to the ridge capping is cracked and requires re bedding and pointing.

A licensed roofing contractor should be called to make a further evaluation and repairs or rectification as needed.

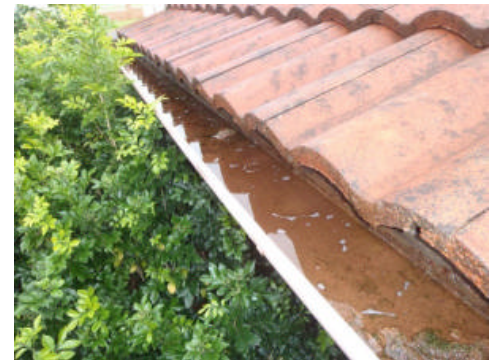
Northwestern elevation:

Gutters are rusted and should be repaired or replaced as necessary. Water is ponding in the gutters and they require realigning.

A licensed roof plumber should be called to make a further evaluation and repairs or rectification as needed.

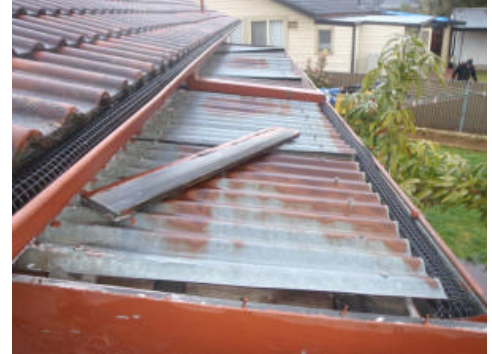
The overall condition of the skillion roof coverings is poor. The metal roofing is rusting and requires treatment to limit further deterioration.

The method used to fix the metal roof is considered incorrect, is inadequate and should be rectified.

A licensed roofing contractor should be called to make a further evaluation and repairs or rectification as needed.

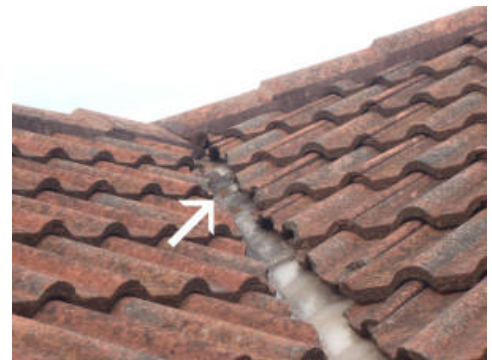
The overall condition of the valley metal is fair. Valley metals are rusting and should be treated or replaced as required.

A licensed roofing contractor should be called to make a further evaluation and repairs or rectification as needed.

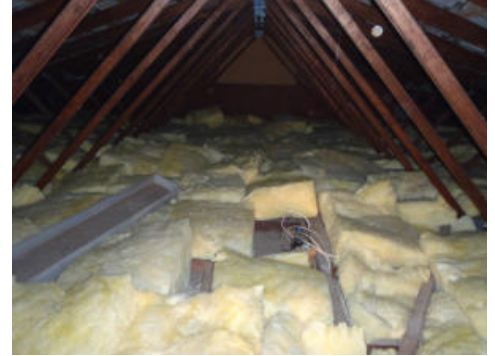
Insulation is present in the roof cavity. This restricted inspection to some roofing timbers. Removal of insulation is not within the scope of a standard visual inspection report.

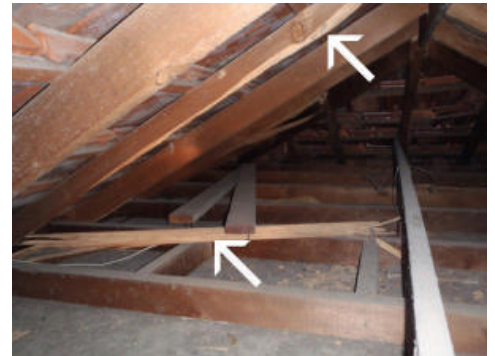
Various roofing timbers:

There appears to be severe damage consistent with timber pest attack to visible accessible timbers. Please refer to pest inspection for details.

A licensed builder should be called to make a further evaluation and repairs or rectification as needed.

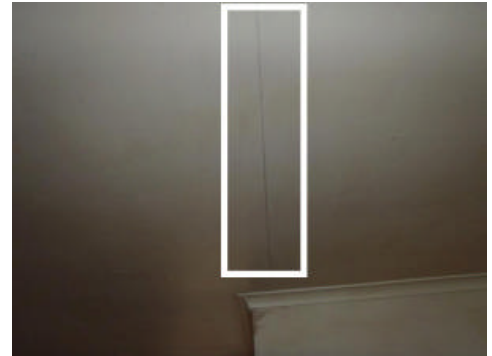
Lounge room:

The condition of the ceilings is generally fair. Minor settlement cracks were noted and these are typical of this type of material. Periodic maintenance may be required.

A plasterer should be called to make a further evaluation and repairs or rectification as needed.

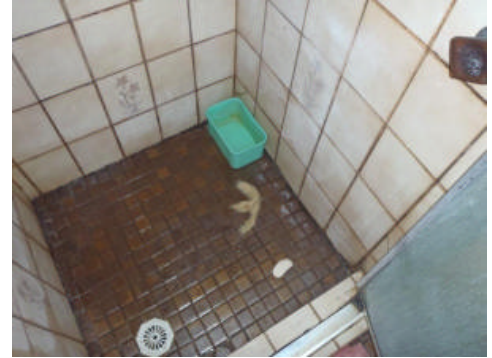
Evidence suggests the shower recess is leaking (see comments under subfloor). Continued leakage may allow damage to surrounding components. Rectification will be required and the extent of works should be determined by a Licensed Builder.

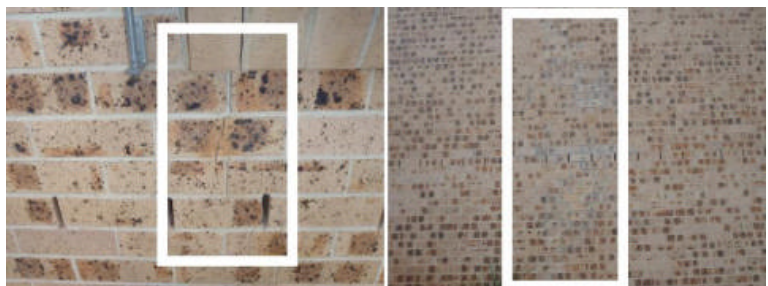
Cracks are evident. Visible cracking has been categorized as a serviceability defect. Cracking of a building element is a serviceability defect where in the opinion of the inspector the function of the building element is impaired however, the expected consequence of this cracking is unknown until further information is obtained. Please refer to section 9 in the Important Information section at the rear of this report for more information.

Cracking can be expected in a building of this age and construction.

Note: Some repairs have been carried out but are not of a professional standard.

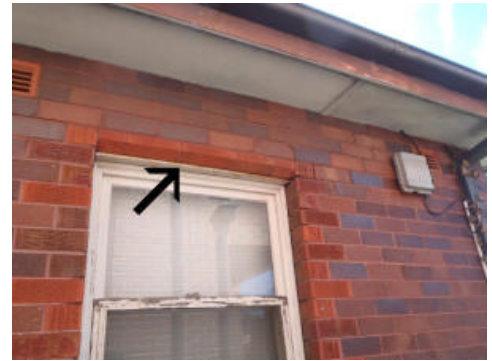
Eastern elevation:

The condition of the lintels is generally fair.

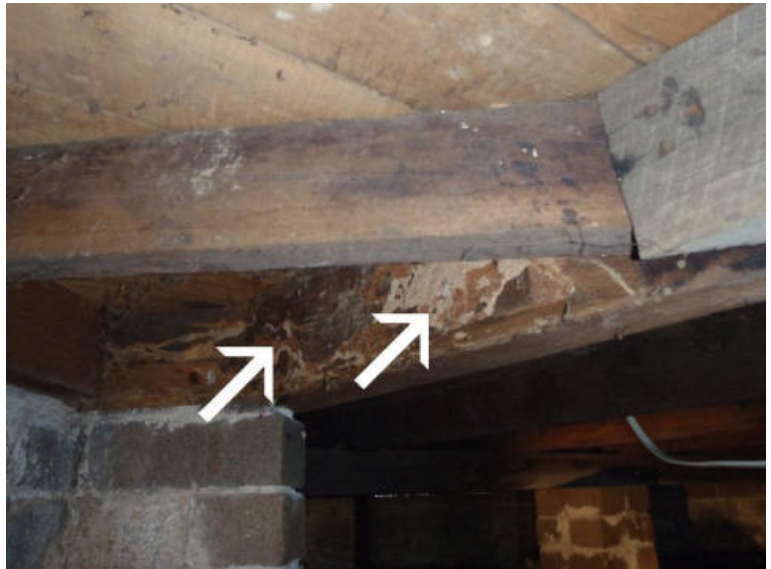
Lounge room:

Flooring timbers:

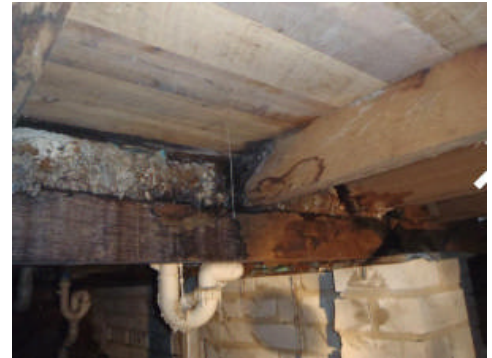
Main bathroom:

Bearers: Floor joist/s:

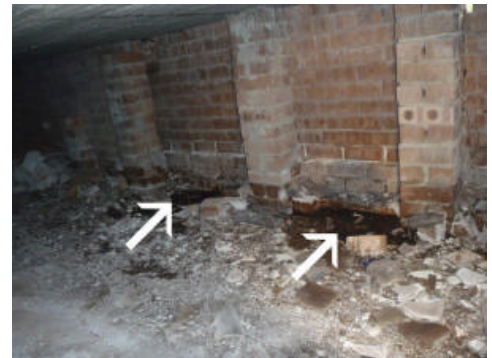
Water is ponding on the ground under the structure. This should be rectified.

Moisture has gained access to unplanned and/or unacceptable areas.

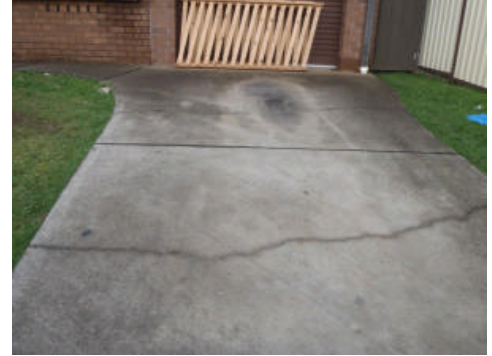
The concrete driveway stands in fair condition. The concrete driveway has some visible cracking that should be monitored for further movement.

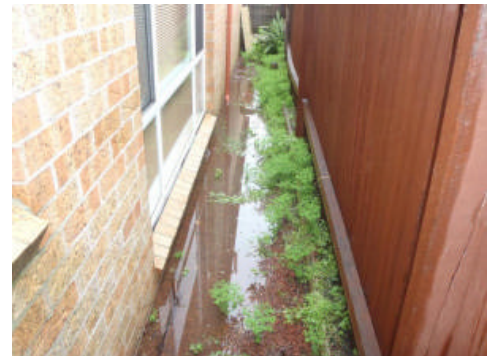
The drainage at the right side of the property appears inadequate. As a result, evidence suggests that surface water has been ponding. Poor site drainage can create unstable foundations that may have an adverse structural effect over time. Rectification is required. Drains should be installed to divert seepage and surface runoff water away from the house. The drains should be connected to the existing stormwater drainage system. Please contact a Licensed Landscaper or Builder for further information.

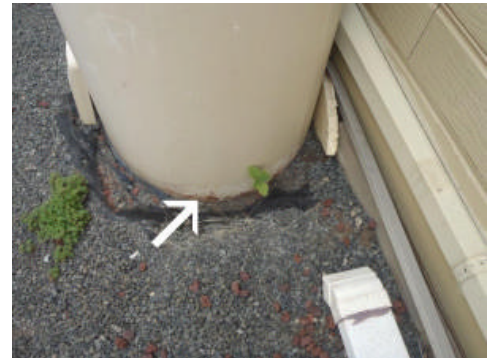
Mains electric hot water system: Located externally: Rust is present to the hot water tank. This should be referred to a licensed plumber.

The unit was manufactured in 1997.
